Gmax Test and Field Inspection Worksheet

Project Name	Weymouth High School - Synthetic Turf Stadium Field
Contact Info	Weymouth Public Schools Phone - 781-335-1460 x20321
Project Address	One Wildcat Way, Weymouth, MA 02190
Date & Time	12/6/13 @ 7:30 am
Weather	Overcast 52 deg F
Site Activity	No activity during inspection

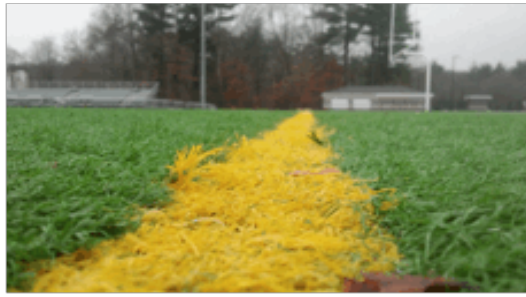
Worn Fiber

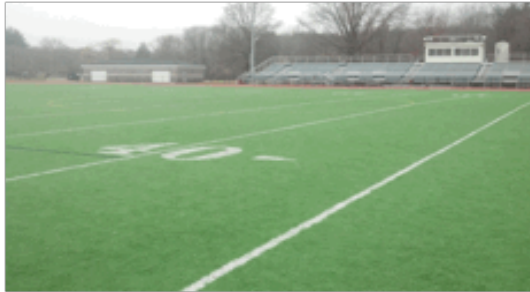
Uneven transition at worn colored fibers
Shedding of white, yellow and green fibers throughout

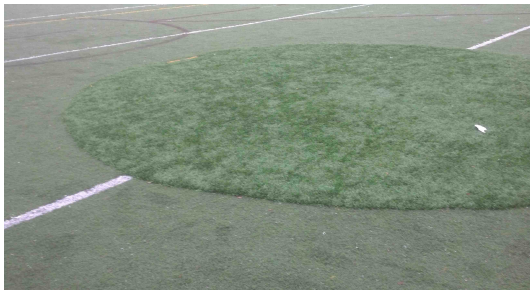
Excessively Worn Fibers with Shedding

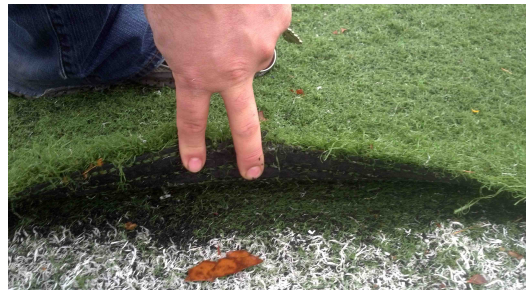
Previous Partial Turf Replacement

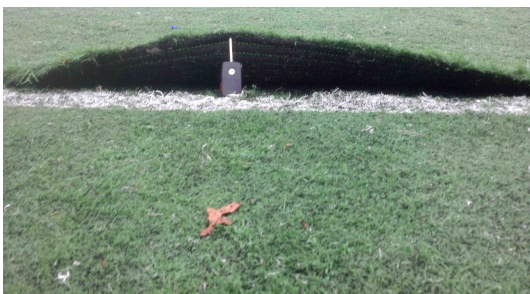
Seam Issue with Shedding

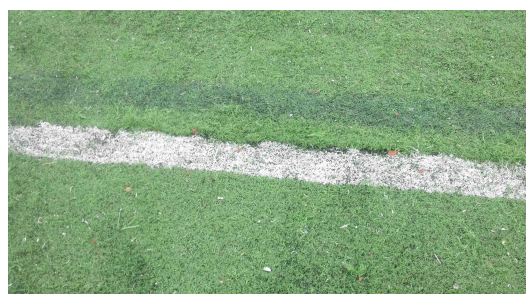
Seam Issue with Shedding

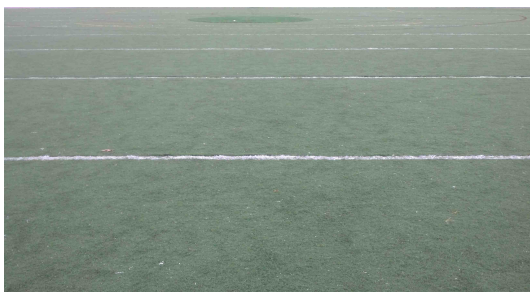
Seam Issue with uneven surface
