# Closing Study

Former Weymouth Public Schools  
Administration Building  
111 Middle Street

In accordance with Weymouth Public Schools Policy FCB, Retirement of Facilities, the following report is a comprehensive closing study providing detailed information to inform the decision of retiring or recycling 111 Middle Street.

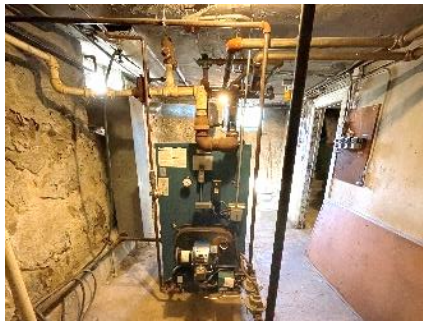
##### Boiler and Heating Distribution

Installed in 2004, This single hot water boiler system rated as poor. Although maintained twice annually, the system is visibly worn and soot is noticeable from the front of the boiler. The distribution system is fair but some areas of the building do not have direct access to baseboard heat or radiators. This unit is also difficult to repair as there is asbestos in many of the reachable areas in and around the units and pipes. Heating system does not have a redundancy – single boiler from 2004.

- Boiler Replacement – 19 years old, close to replacement
- Building Envelope Renovation – South, East and portions of the North need siding replacement, trim, and doorway replacement – poor condition.
- Rooftop Ventilation Upgrades. HVAC unit required more than routine maintenance.
- Roof Replacement – Ponding occurring near center of roof.
- Life Safety Systems – Code compliance

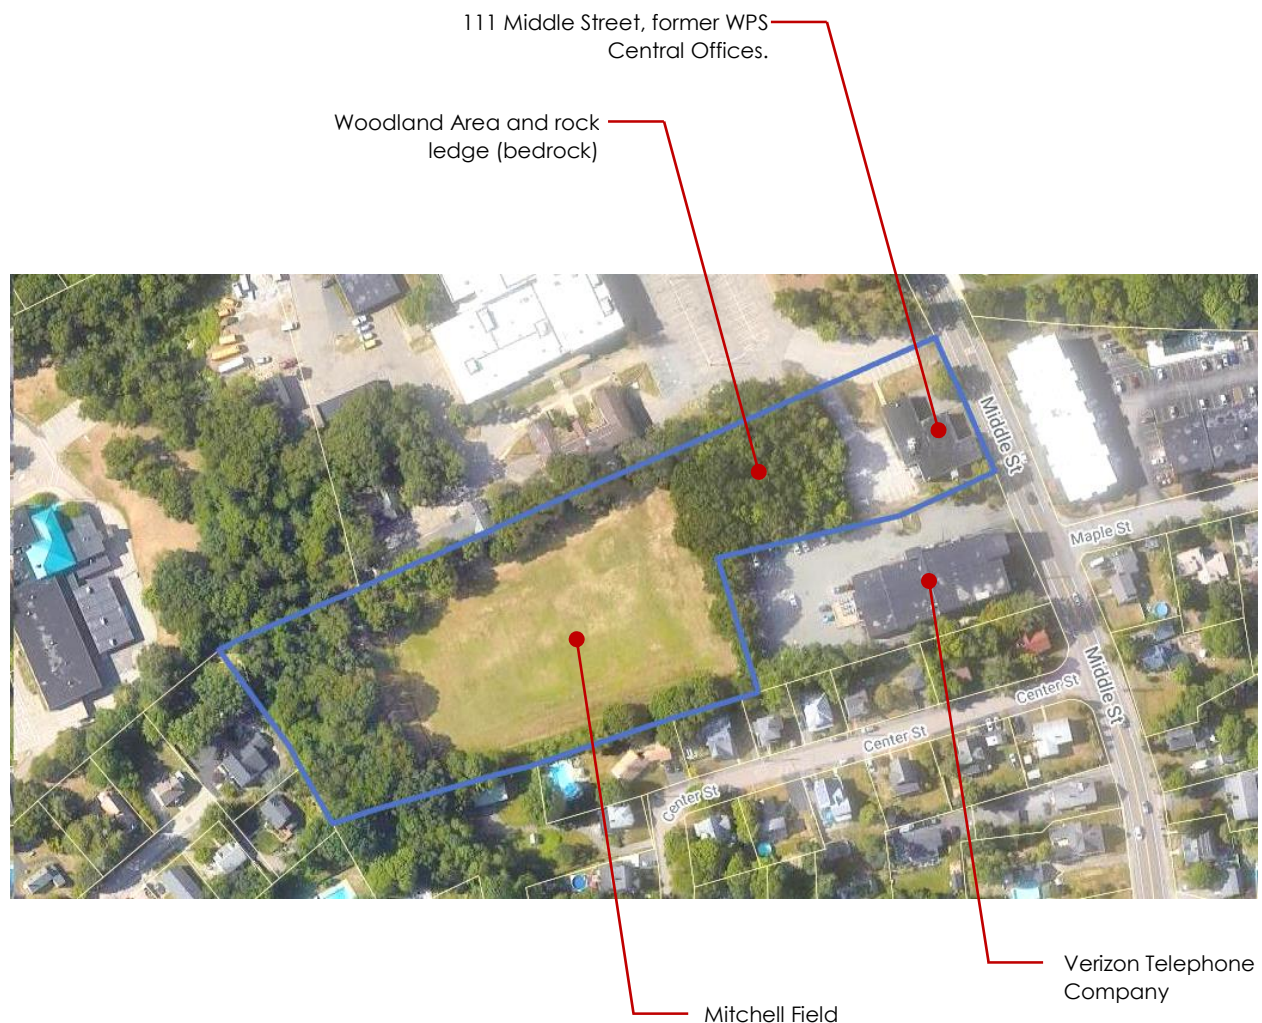
111 Middle street, formerly known as Weymouth Public Schools Administration Building, is a 5,984 NSF, 1-1/2 story building located at 111 Middle Street in East Weymouth. The closest major intersection is Middle and Broad Streets. The structure was completed 1940. 111 has 5.05 acres of woodlands, parking, grassy areas and includes Mitchell field. The surrounding development abuts 6 residential properties, all active and one industrial property, a Verizon switching station. In addition, Abigail Adams ECC and Central office as well as Academy Avenue Elementary School. about the property. There are no EPA protected wetlands, conservation areas or any other protected lands on this property. There is a significant amount of ledge (bedrock) in the woodland area behind the property. The elevation drops to legion field and to middle street (111 resides on a small hill). There is no room for expansion of this property.

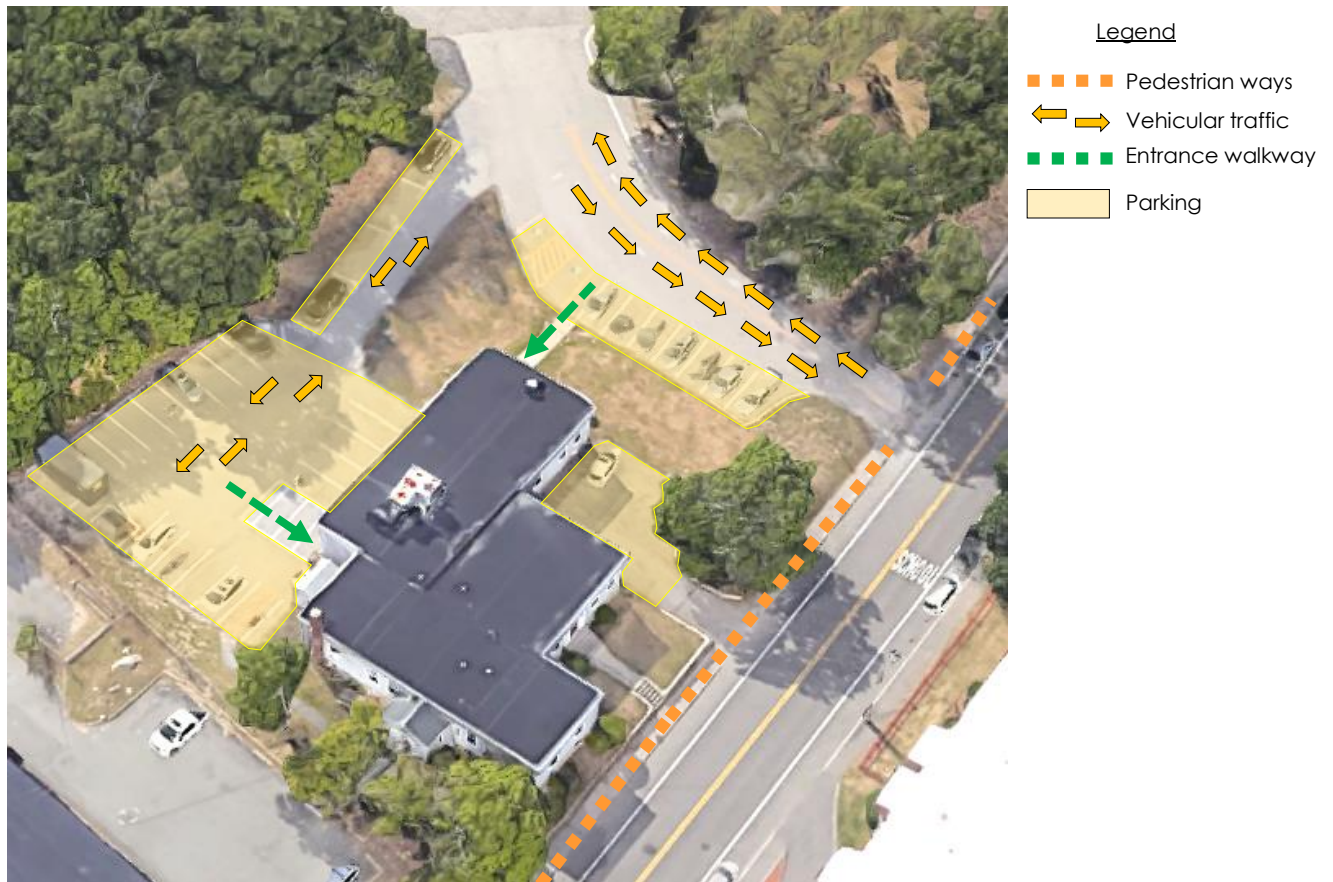
Access to and from 111 Middle street is adequate. There are 34 existing parking slots. Parking regulations and standards call for a maximum of 24. 111 is well within meeting the guidelines for parking. There is a large sidewalk in the front of the property on Middle Street and several crosswalks in the area.
